Manhole Inspection Summary

Manhole # S15GG1014MH

Insp Date: **11/7/08 7:17 AM**

Location Address: **2600 OSWEGO AVE**

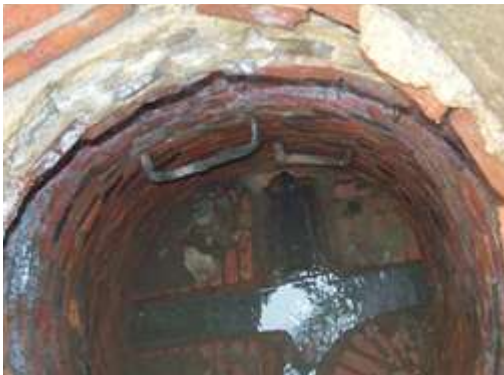
Defect 1

Condition: ☒ Sound ☐ Cracked ☐ Root Intrusion ☐ Deteriorated ☐ Leaks ☐ Debris

DEBRIS ON BENCH

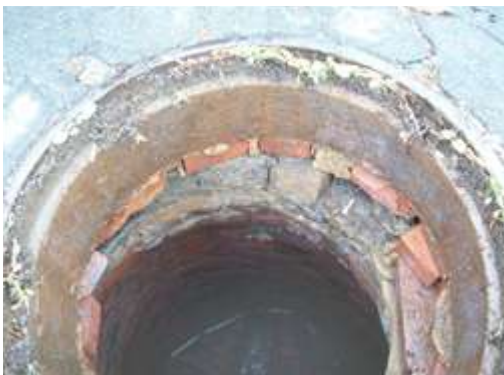
Defect 2

Condition: ☐ Sound ☐ Cracked ☐ Root Intrusion ☒ Loose Brick ☒ Deteriorated

DETERIORATED AND LOOSE BRICKS
OF FRAME ADJUSTMENT

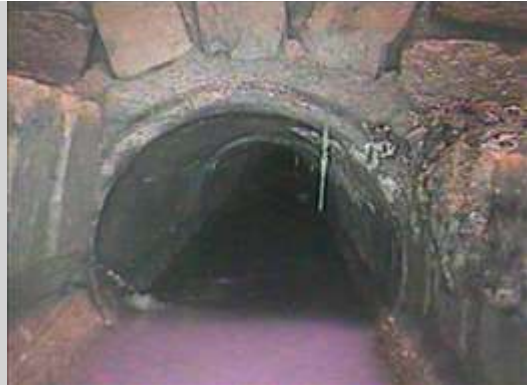
12 O'Clock Outflow

8 in. Circular Gravity Sewer
Pipe Out @ 12 O'Clock

Pipe Height: (in.) Direct
Pipe Material: **Clay** ☐ Pipe Lined
Invert Depth: **9.00** (ft.) Flow Characteristics: **Slow**
Deposits: ☒ None ☐ Mud ☐ Sludge ☐ Debris ☐ Grease
Silt Depth: (in.) Deposits Extent:
Infiltration: **None** Pipe Seal Cond: **Sound**

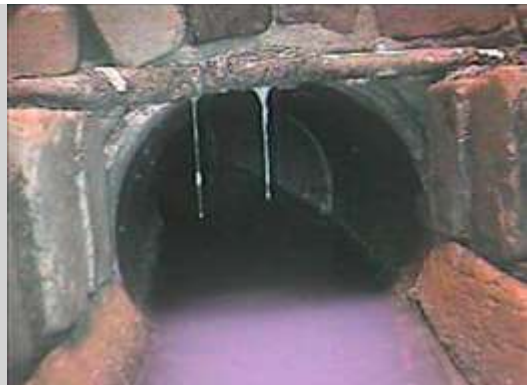
3 O'Clock Inflow

8 in. Circular Gravity Sewer
Pipe In @ 3 O'Clock

Pipe Height: (in.) Direct
Pipe Material: **Clay** ☐ Pipe Lined
Invert Depth: **8.95** (ft.) Flow Characteristics: **Slow**
Deposits: ☒ None ☐ Mud ☐ Sludge ☐ Debris ☐ Grease
Silt Depth: (in.) Deposits Extent:
Infiltration: **None** Pipe Seal Cond: **Sound**

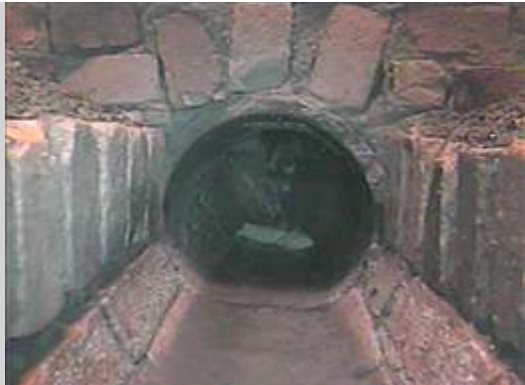
6 O'Clock Inflow

Pipe In @ 6 O'Clock

Drop: **Inside** **Direct**

☒ Possible Illicit Connection

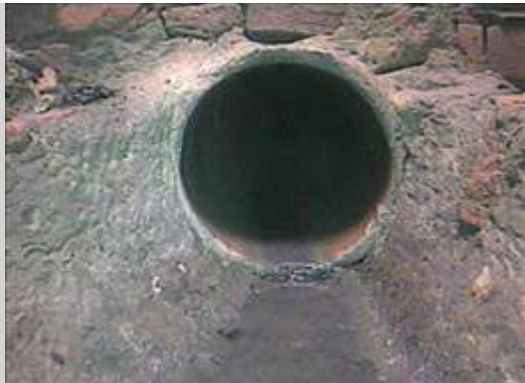
9 O'Clock Inflow

Pipe In @ 9 O'Clock

Infiltration: **None** Pipe Seal Cond: **Broken**
